Manhole Inspection Summary

Manhole # S31G__028MH

Location Address: **14 s eutaw st**

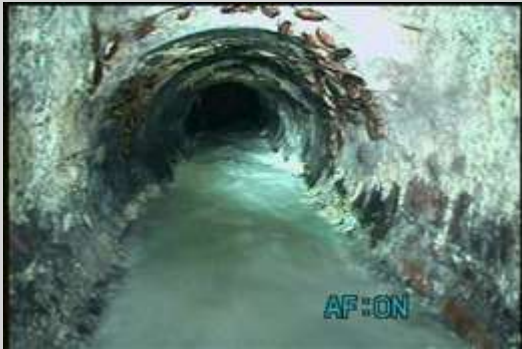
12 O'Clock Outflow

12 in. Circular Gravity Sewer
Pipe Out @ 12 O'Clock

Invert Depth: **18.16** (ft.) Flow Characteristics: **Fast**

Infiltration: **None** Pipe Seal Cond: **Unknown**

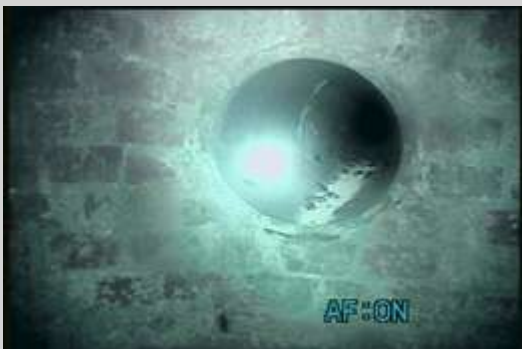
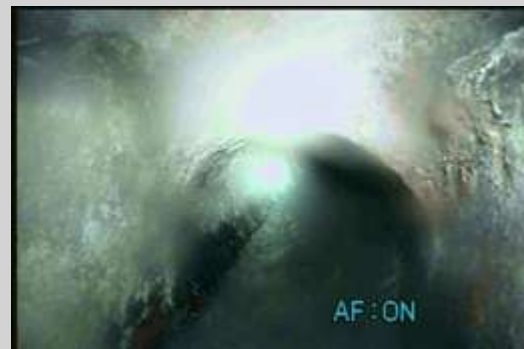
3 O'Clock Inflow

10 in. Circular Gravity Sewer
Pipe In @ 3 O'Clock

Drop In @ 3 O'Clock

Invert Depth: **13.00** (ft.) Flow Characteristics: **Fast**

Infiltration: **None** Pipe Seal Cond: **Unknown**

Drop: **Outside Direct**

Drop Condition: **Open**

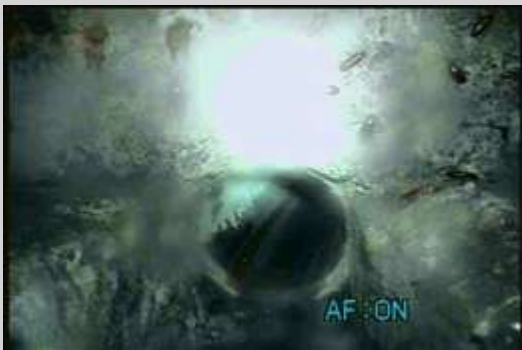
8 O'Clock Inflow

6 in. Circular Gravity Sewer

Pipe In @ 8 O'Clock

Infiltration: **None** Pipe Seal Cond: **Unknown**
